GLASGRID[®] PAVEMENT REINFORCEMENT PRODUCT EVALUATION

1. Report No. FEP-03-03	2. Government Accession No.	3. Recipients Catalog No.	
4. Title and Subtitle GlasGrid® Pavement Reinforcement Product Evaluation		5. Report Date April 2003

WISCONSIN FEDERAL EXPERIMENTAL PROJECT # WI-89-03

FINAL REPORT #FEP-03-03

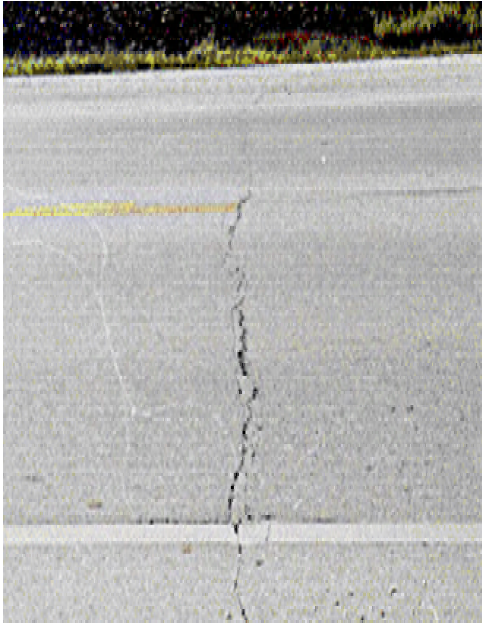
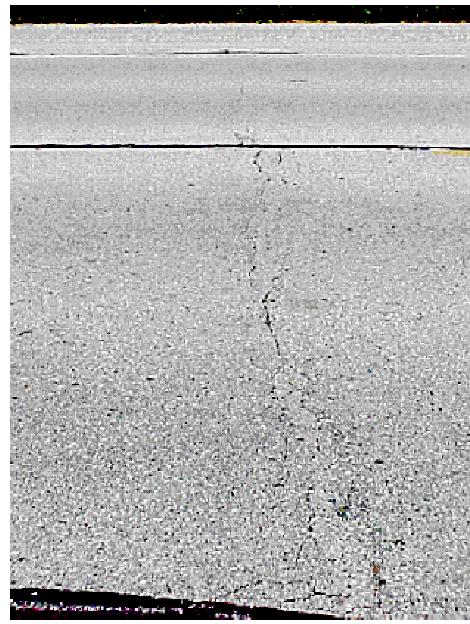
The photos above show Type III banded cracking in the single strand (a and b) and double strand (c and d) GlasGrid[®] pavement reinforcement test sections. Notice the multiple cracks in close proximity to the main crack.

The types of cracks that developed within the pavement test sections were also determined to be significant factors in the performance evaluation. As shown in Figure 3 on pages 15 and 16, the reflective cracks that developed in the control sections were predominantly transverse Type I single cracks (less than 1/2-inch in width), while the cracks in the GlasGrid[®] reinforced test sections were mainly transverse Type III banded cracks (multiple cracks in close proximity resulting in a narrow band of cracks). Type III banded cracks are more severe than Type I single cracks, are more costly to maintain, and typically have a greater negative impact on the overall service life of the pavement.

The banded cracks developed in the single strand and double strand GlasGrid[®] reinforced test sections within the first year, the severity of which increased over the years of the study. Over the first five years of the study, the band cracking in the single strand sections was tight with the cracks close together, while the band cracking in the double strand sections was more spread out. Over the remaining five years of the study, the

banded cracks of the single strand sections widened and were comparable to those of the double strand section by the end of the study.

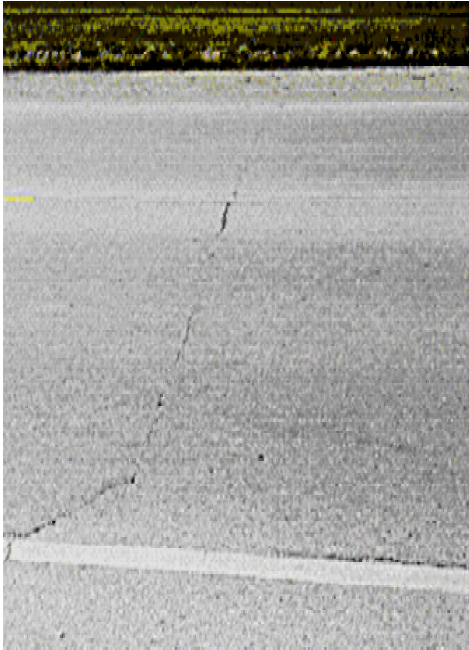
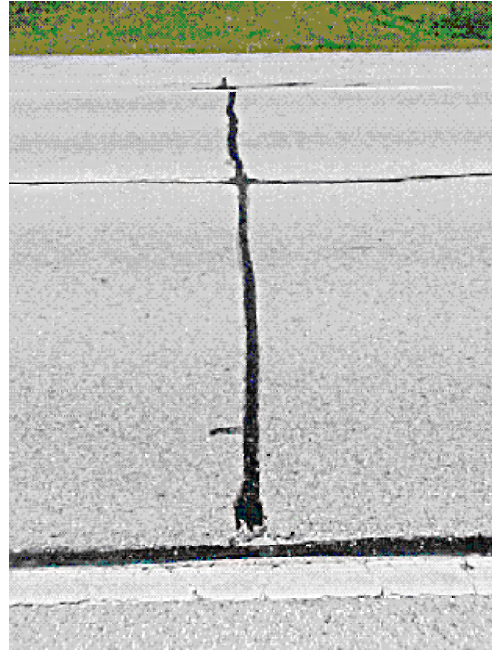
The above photos (e and f) show Type 1 ($< \frac{1}{2}$ -inch) cracking in the control sections. This section does not have any reinforcement between the asphaltic concrete pavement layers. Notice the crack is less than $\frac{1}{2}$ -inch wide and has no other cracks within close proximity of it.
